**Flood Control Project Maintenance
Levee Inspections**

2011 Channel Summary Report

Merced Streams Group

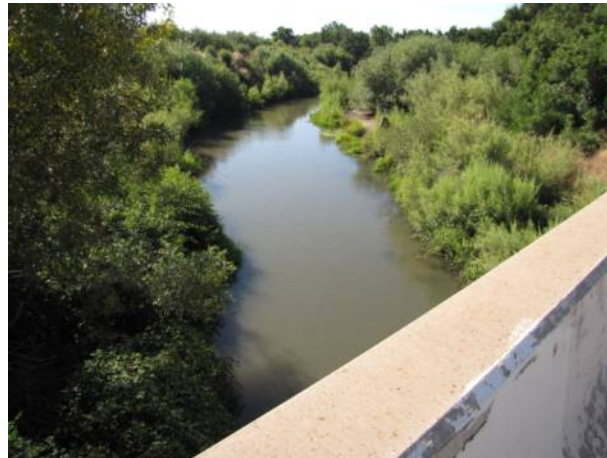
Levee Mile Report Line	16
Start Levee Mile	0.00
End Levee Mile	0.00
Location	
Category	Channels
Item	Vegetation & Obstructions
Arboleda Dr.crossing the Bear Creek looking downstream at channel. Photo taken 7-19-2011.	
phillips_c_20110823_092.jpg

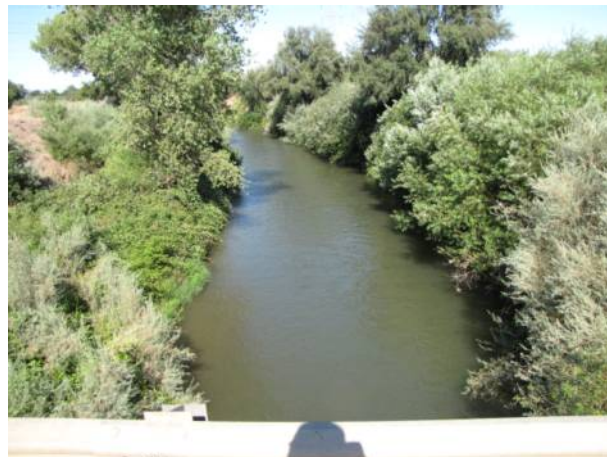
Levee Mile Report Line	21
Start Levee Mile	0.00
End Levee Mile	0.00
Location	
Category	Channels
Item	Vegetation & Obstructions
Standing on the Kibby Road bridge crossing the Bear Creek facing upstream. This photo was taken 7-19-2011	
phillips_c_20110829_093.jpg

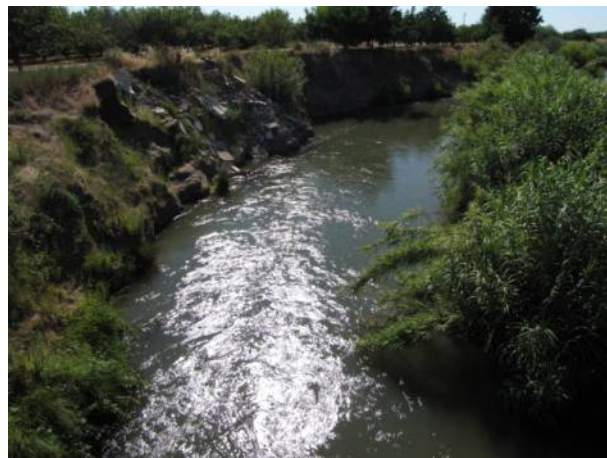
Levee Mile Report Line	26
Start Levee Mile	0.00
End Levee Mile	0.00
Location	
Category	Channels
Item	Vegetation & Obstructions
Kibby Rd crossing the Bear Creek looking downstream from bridge. Photo taken 7-19-2011.	
phillips_c_20110829_094.jpg

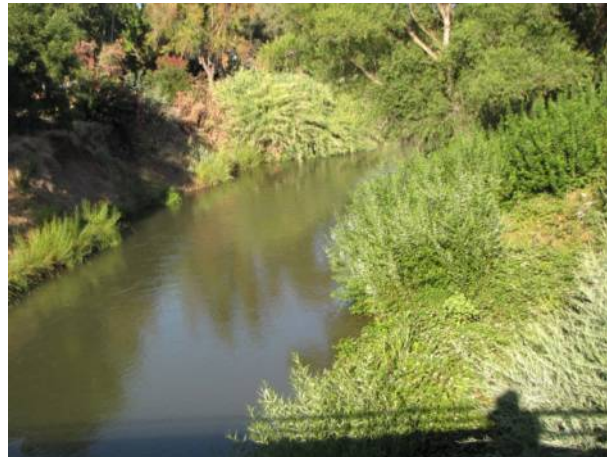
Levee Mile Report Line	31
Start Levee Mile	0.00
End Levee Mile	0.00
Location	
Category	Channels
Item	Vegetation & Obstructions
McKee Rd crossing the Bear Creek facing upstream. Vegetation present on both banks does not divert flow in channel. Photo taken 7-19-2011.	
phillips_c_20110829_096.jpg

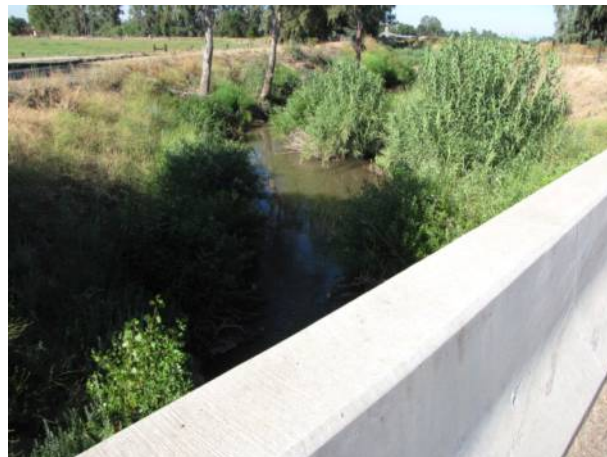
Levee Mile Report Line	66
Start Levee Mile	0.00
End Levee Mile	0.00
Location	
Category	Channels
Item	Vegetation & Obstructions
Hwy 140 bridge crossing the Bear Creek facing downstream. Wild growth on both banks and in channel.	
phillips_c_20110831_107.jpg

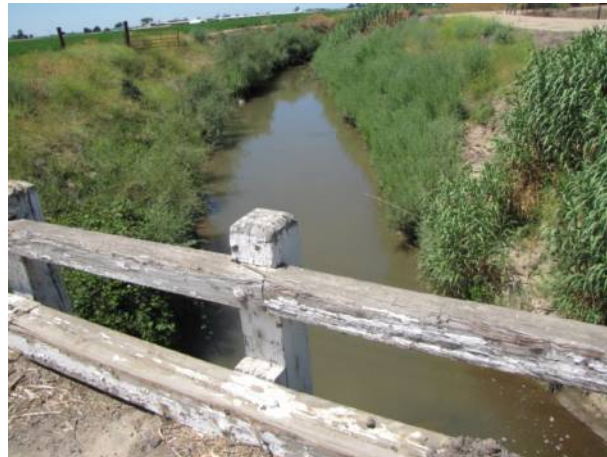
Levee Mile Report Line	81
Start Levee Mile	0.00
End Levee Mile	0.00
Location	
Category	Channels
Item	Vegetation & Obstructions
Dickensen Ferry Rd. looking upstream at Bear Creek vegetation present on both banks and in channel Right Bank. Photo taken 7-20-2011.	
phillips_c_20110831_112.jpg

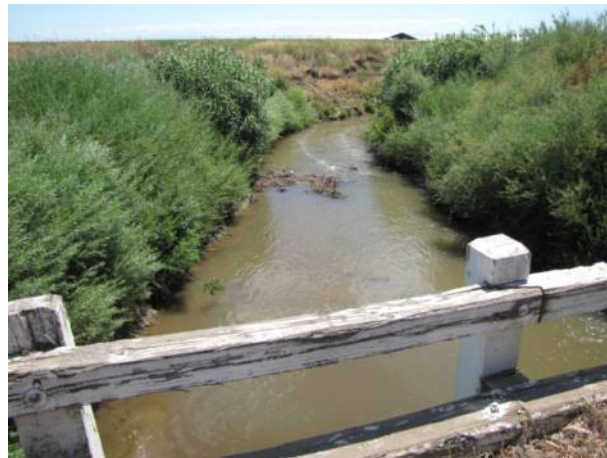
Levee Mile Report Line	86
Start Levee Mile	0.00
End Levee Mile	0.00
Location	
Category	Channels
Item	Vegetation & Obstructions
Dickerson Ferry Rd. looking downstream at Bear Creek. Photo taken 7-20-2011. Some vegetation in channel r on right bank and in the channel	
phillips_c_20110831_113.jpg

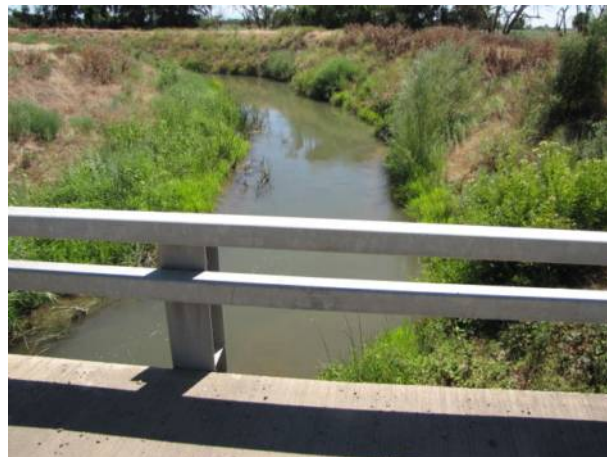
Levee Mile Report Line	21
Start Levee Mile	0.00
End Levee Mile	0.00
Location	
Category	Channels
Item	Vegetation & Obstructions
Looking upstream of Black Rascal Creek at Franklin Road crossing. Photo taken 7-13--2011.	
phillips_c_20110718_005.jpg

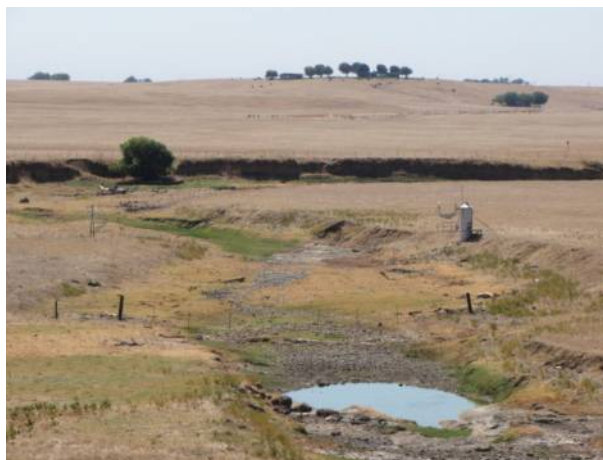
Levee Mile Report Line	1
Start Levee Mile	0.00
End Levee Mile	0.00
Location	
Category	Channels
Item	Vegetation & Obstructions
Looking downstream from Burns Creek Dam. Photo taken 9-27-2011.	
phillips_c_20110930_118.jpg

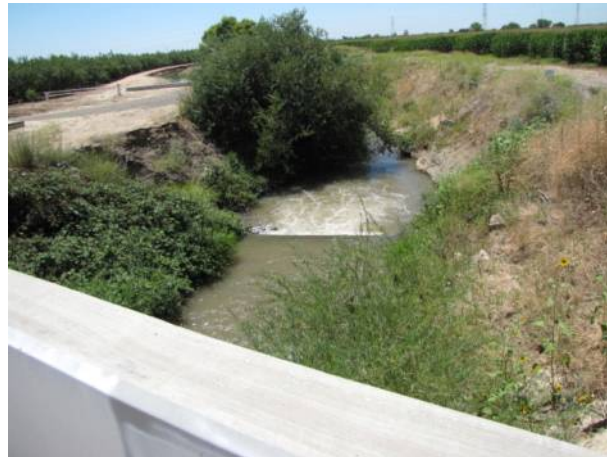
Levee Mile Report Line	78
Start Levee Mile	0.00
End Levee Mile	0.00
Location	
Category	Channels
Item	Erosion / Bank Caving
Erosion exist on L/B slope of the Mariposa creek downstream from Arboleda road crossing, 37.25690 -120.37947. 7-19-2011.	
phillips_c_20110726_029.jpg

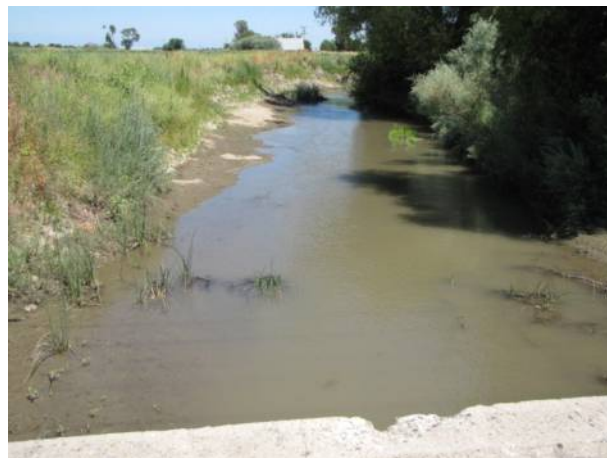
Levee Mile Report Line	91
Start Levee Mile	0.00
End Levee Mile	0.00
Location	
Category	Channels
Item	Vegetation & Obstructions
View of Mariposa Creek upstream from Hwy 59, this channel appears to have been dredged at this location recently. 7-19-2011.	
phillips_c_20110726_032.jpg

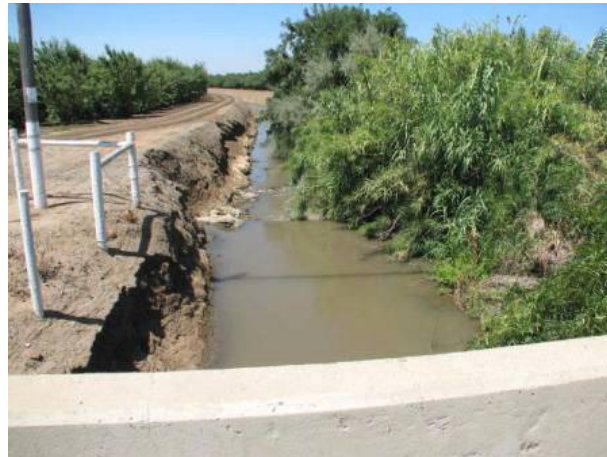
Levee Mile Report Line	106
Start Levee Mile	0.00
End Levee Mile	0.00
Location	
Category	Channels
Item	Vegetation & Obstructions
08/02/2011 Tree growing in channel on downstream side of Highway 59 crossing.	
jeto_c_20110802_037.jpg

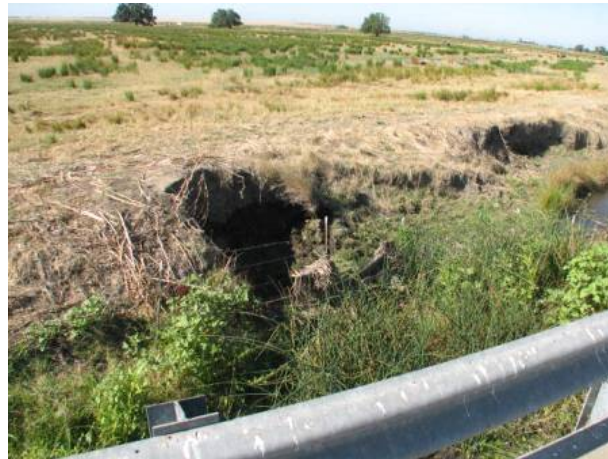
Levee Mile Report Line	20
Start Levee Mile	0.00
End Levee Mile	0.00
Location	
Category	Channels
Item	Encroachments
08/02/2011 Wire fence across channel downstream of Childs Ave. crossing.	
jeto_c_20110802_005.jpg

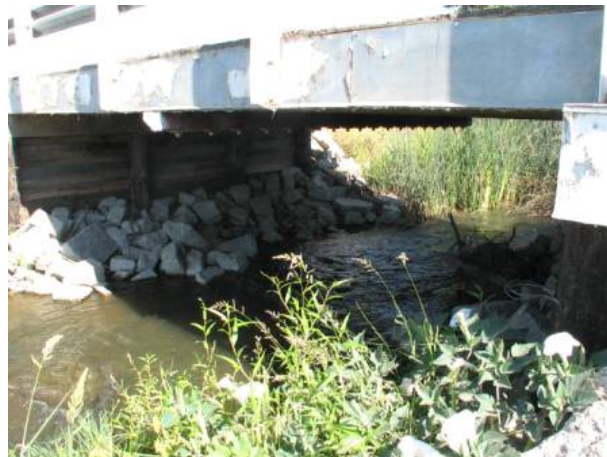
Levee Mile Report Line	29
Start Levee Mile	0.00
End Levee Mile	0.00
Location	
Category	Channels
Item	Revetments
08/02/2011 Mission Ave. crossing rip rap shown in channel.	
jeto_c_20110802_008.jpg

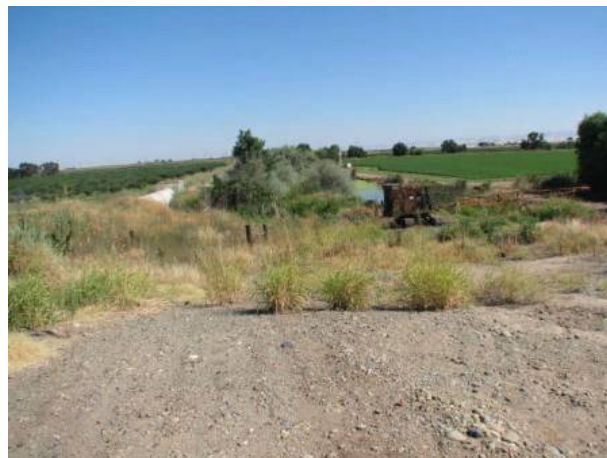
Levee Mile Report Line	31
Start Levee Mile	0.00
End Levee Mile	0.00
Location	
Category	Channels
Item	Vegetation & Obstructions
08/02/2011 Upstream view at Le Grand Canal. Note obstructive vegetation.	
jeto_c_20110802_009.jpg
